Fatigue Failure of Coupling Bolts

KWS Manufacturing

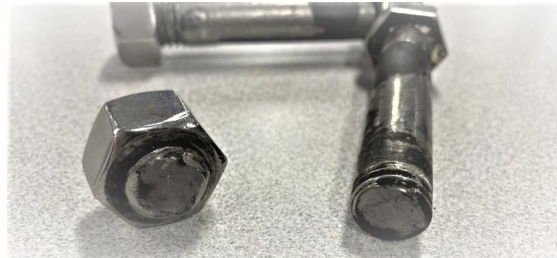
Misalignment and vibration at the drive end of a screw conveyor causes cyclical movement of the drive shaft in the drive end of the screw. The movement is transferred to the coupling bolts, causing the bolts to fatigue and fail at the bolt heads or the nuts. The bolt head or nut will break off flush with the outside diameter of the pipe of the screw.

It is commonly assumed that the failure is due to the coupling bolts shearing off. Based on the location of the failure on the outside of the pipe, it is impossible to have a shear failure because there is no shear loading on the outside of the pipe. Another common misconception is that the bolts have been over-torqued, causing the head or nut to "pop off". Coupling bolts must be torqued to proper settings as shown in the KWS Operations and Maintenance Manual available on the KWS website.

Coupling Bolt Failure Due to Screw
Conveyor Misalignment and Excessive Vibration

Proper alignment and drive support are extremely important for screw conveyors and any rotating equipment. A properly aligned and supported screw conveyor will operate thousands of hours without issue. Screw conveyors are one of the most reliable and cost-effective types of conveyors in the bulk material handling industry. The KWS website is a wealth of information for designing, installing, operating, and trouble-shooting screw conveyors. Please visit our website or give us a call.

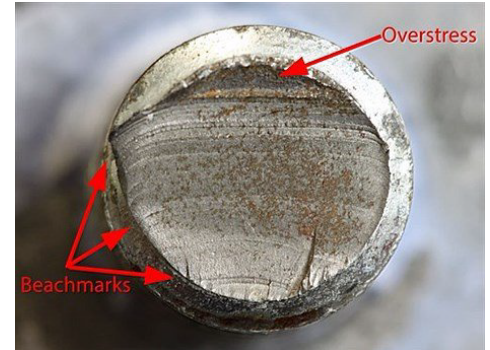
Fatigue loading is repeated, cyclic loading. Fatigue cracks are progressive, happen over time, and initiate from an area of stress concentration. Areas of stress concentration on a coupling bolt are the sharp transition from the shank to the bolt head or the threads of the bolt. Fatigue cracks and failures commonly have beach marks, or alternating stripes of lighter and darker colors. The different colors result from different loading levels. A fatigue failure is easily identified by visually inspecting the failed coupling bolt. You can clearly see the beach marks on the failed coupling bolt. Please see the attached photos.

Beach Marks Clearly Show Fatigue Failure of Coupling Bolt
