Fatigue Failure of Coupling Bolts

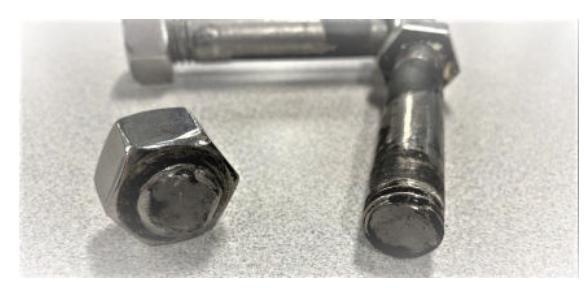
Misalignment and vibration at the drive end of a screw conveyor causes cyclical movement of the drive shaft in the drive end of the screw. The movement is transferred to the coupling bolts, causing the bolts to fatigue and fail at the bolt heads or the nuts. The bolt head or nut will break off flush with the outside diameter of the pipe of the screw.

Coupling Bolt Failure Due to Screw Conveyor Misalignment and Excessive Vibration

Proper alignment and drive support are extremely important for screw conveyors and any rotating equipment. A properly aligned and supported screw conveyor will operate thousands of hours without issue. Screw conveyors are one of the most reliable and cost-effective types of conveyors in the bulk material handling industry. The KWS website is a wealth of information for designing, installing, operating, and trouble-shooting screw conveyors. Please visit our website or give us a call.

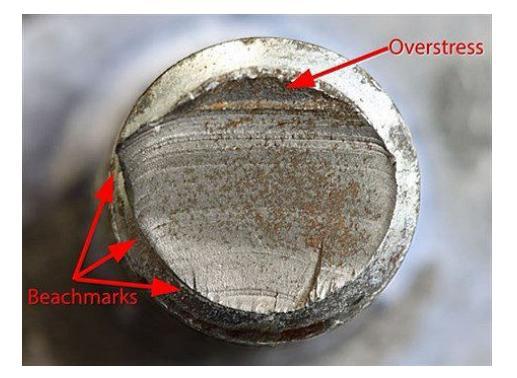
Fatigue loading is repeated, cyclic loading. Fatigue cracks are progressive, happen over time, and initiate from an area of stress concentration. Areas of stress concentration on a coupling bolt are the sharp transition from the shank to the bolt head or the threads of the bolt. Fatigue cracks and failures commonly have beach marks, or alternating stripes of lighter and darker colors. The different colors result from different loading levels. A fatigue failure is easily identified by visually inspecting the failed coupling bolt. You can clearly see the beach marks on the failed coupling bolt. Please see the attached photos.

Beach Marks Clearly Show Fatigue Failure of Coupling Bolt
