KWS Replacement Screw
Eliminates Problems with
Existing Screw

KWS Replaces Failed Screw at Georgia Pacific Mill in Brewton, AL

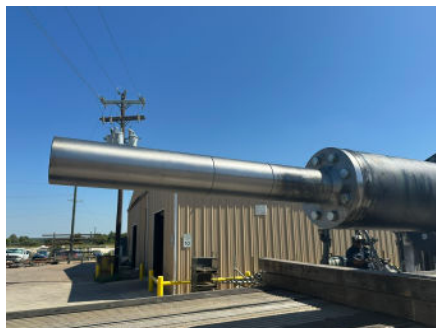
Flanged Drive and Tail Shafts are
Machined from Single Piece of Bar Stock
and Will Not Fail

The new KWS replacement screw assembly was a drop-in replacement with no modifications to the existing housing and drive unit. Using proven KWS design standards, KWS engineers provided a superior screw with full penetration welds on the flange-to-pipe connections that will not fail. Flanged drive and end shafts were machined from a single piece of bar stock to provide an unbreakable connection. The completed screw assembly was tested and straightened in a lathe to within 0.0050-inches TIR. To accommodate for thermal expansion, KWS provided a custom slider base trough end for the tail end to allow the screw and pillow block tail bearing to expand and contract axially.

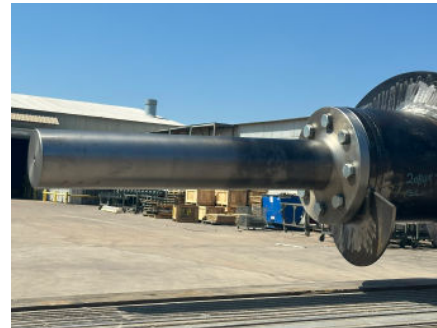
Flanged Tail Shaft is Bolted to Screw
Assembly

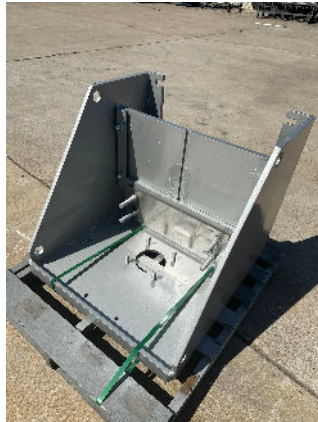
KWS Slider Base Trough
End

Slider Base Allows for Axial
Thermal Expansion
