## KWS Redesigns Bucket Elevator to Double Capacity at CertainTeed in Portland, OR

### General Description

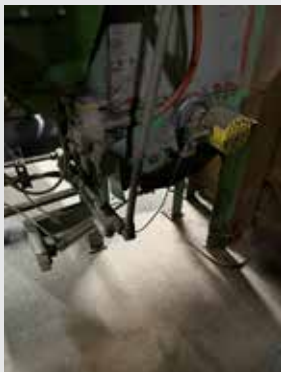
Existing Bucket Elevator was Worn Out and Could Not Meet Capacity

CertainTeed had been utilizing an undersized bucket elevator for the current demand causing product to fall out of the buckets and fill the bottom of the elevator with material. This issue required operators to spend countless labor hours opening the bottom of the elevator and cleaning out the unused product. CertainTeed looked to KWS to design and manufacture a bucket elevator for their increased capacity and reduce loss of product. Due to lack of space, the new bucket elevator had to be custom designed to fit in the existing area while increasing capacity. KWS provided a solution that met and exceeded CertainTeed's requirements.

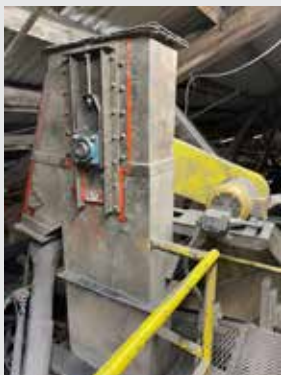
Material Fell Out of Buckets and Filled Boot Section

CertainTeed Added a Clean-Out Door to Existing Bucket Elevator to Clean Out Boot Section

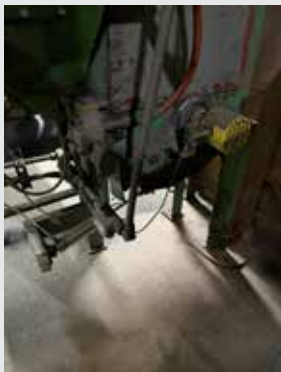
Existing Bucket Elevator was Worn Out and Could Not Meet Capacity

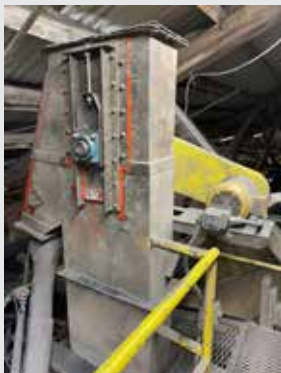
Material Fell Out of Buckets and Filled Boot Section

CertainTeed Added a Clean-Out Door to Existing Bucket Elevator to Clean Out Boot Section

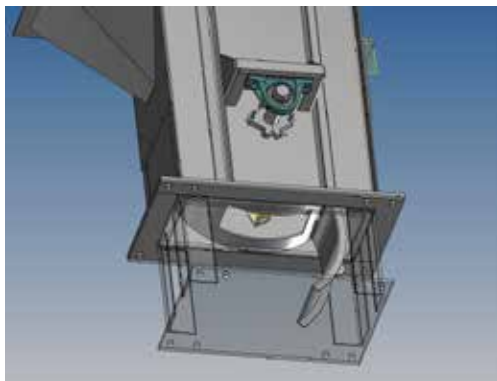
Redesigned KWS Bucket Elevator Doubled Capacity in Same Footprint

KWS designed and manufactured a unique bucket elevator for this project. The bucket elevator was designed to deliver twice the capacity in the same casing size as the existing elevator. The new KWS bucket elevator was installed quickly with a few minor modifications to existing structure. KWS and CertainTeed designed a unique pneumatically controlled clean-out door for ease of access for routine maintenance. Since grit is extremely abrasive, abrasion resistant plate was installed on the inside of the head and boot sections to prevent wear and increase the life of the equipment.

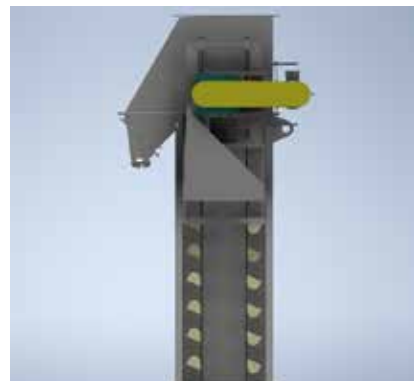
Head Section Take Up Allows Close Clearance Clean Out in Boot Section

KWS located the belt adjustment take-up in the head section, creating close clearance between the buckets and curved bottom plate of the boot section. Close clearance eliminates material buildup in the boot section and greatly reduces maintenance time.

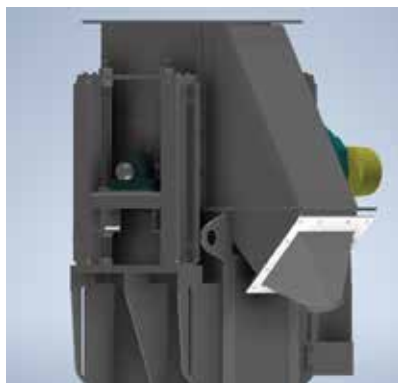
Curved Bottom Plate Creates Close Clearance in Boot Section
