## Fatigue Failures in Screw Conveyors

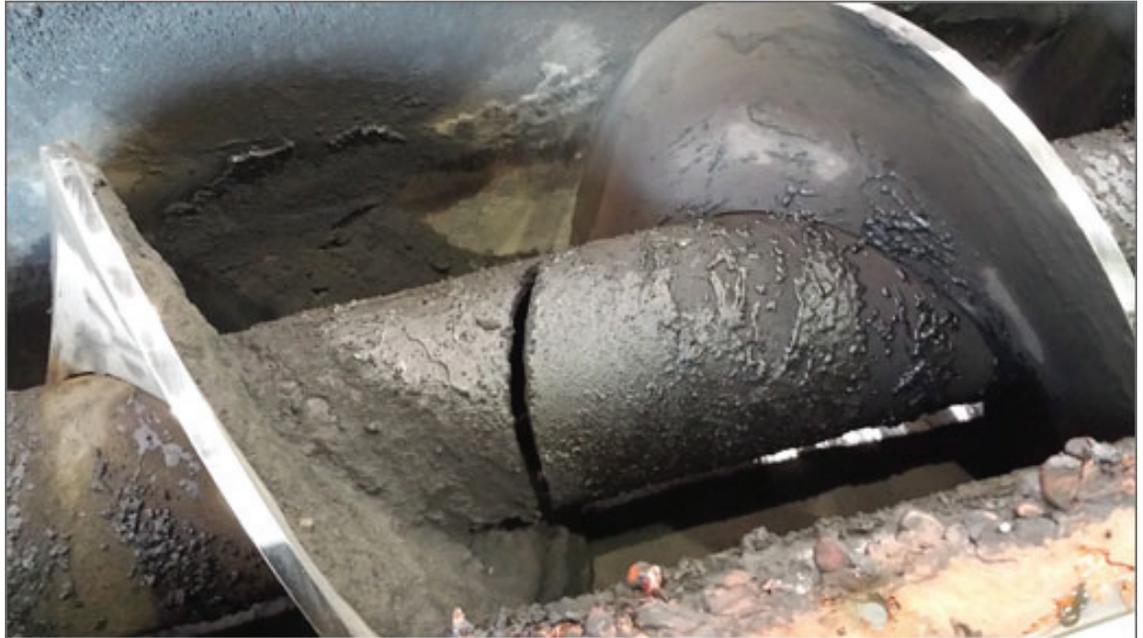
**Figure 1 - Typical Fatigue Failure**

In very rare applications a bulk material will form a permanent layer in the bottom of the housing. This layer will build up over time and cause the screw to deflect in the center. Because each end of the screw is held fixed by the bearings, as the screw is pushed up in the center, enormous cyclical forces are imparted on the center pipe of the screw as it rotates. Every revolution of the screw causes a complete reversal of the forces on the center pipe. This condition is very similar to taking a piece of wire and bending it back and forth until it breaks or fatigues. Most fatigue failures are easy to identify because the break is almost perpendicular to the centerline of the screw conveyor and the location of the fatigue failure is typically in the center of the screw section as shown in Figure 1.

In your application you are adding water to the flyash which is making the problem worse. The flyash/water combination is sluggish to convey and sticks to the bottom of the housing. It hardens like concrete and builds up. The outside diameter of the screw flights will become shiny as they wear against the layer of material in the trough as shown in Figure 1. This is a key indicator that you have buildup. In some extremely abrasive applications the outside diameter of the flights will actually wear down, causing excessive horsepower draw and screw failure.

The root cause of the problem is the buildup of hardened material in the bottom of the housing. This hardened material must be eliminated or reduced in order prevent screw conveyor failure. One solution is to add trough liners to reduce the gap between the outside diameter of the screw and the housing. If the layer of material is very thin, then it will break loose and be conveyed downstream. I would recommend using ¼-inch thick abrasion resistant plate for the liner material. The abrasion resistant plate will wear longer than mild steel.

Another solution is to mount the screw on larger diameter pipe with a heavier wall thickness. Currently, the screw is mounted on 6-inch schedule 80 pipe. This design is perfectly acceptable for almost every application because the screw deflection is minimal. Based on the information provided about the material buildup, using a more rigid screw would help solve the problem. I would suggest using 8-inch schedule 120 pipe with a 0.72-inch wall thickness. Larger, thicker pipe will provide extra rigidity and greater resistance to being pushed up in the housing.

Additionally, adding cutter teeth or weld-on hardsurfacing to the outside diameter of the screw flights would reduce the gap between the screw and housing as well as provide a cutting surface to cut through the hardened layer. Carbide cutting teeth can be added to the outside diameter of the screw and will cut through almost any hardened material in the housing.

As stated previously, the key to solving the problem is removing the hardened material in the bottom of the housing. The combination of adding liners along with either mounting the screw on larger pipe or adding cutter teeth will most certainly solve almost any problem of this type.
