Coupling Bolt Wear and Failure

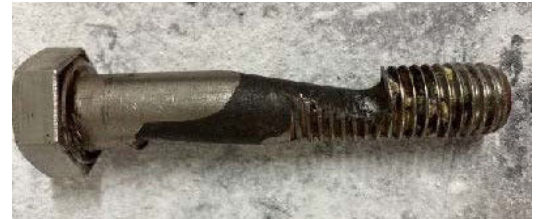
Thank you for the question and for sending photos of the wear and failure. Cycling the vertical screw conveyor on and off 20 times per hour is creating a "hammering effect" on the drive end connection to the screw. The CEMA 2-bolt coupling shown in the photos is subjected to full-motor torque at every start up. The "hammering effect" is loosening up the connection between the coupling bolts and screw. As the clearance increases, the "hammering effect" becomes greater, until the coupling bolts or screw fails.

Shank of Coupling Bolt is Worn in Bearing Area Due to Repeated Starts and Stops of Vertical Screw Conveyor

- 1. Reduce Cycle Times** – Reducing the number of starts and stops will reduce the "hammering effect" and increase the life of the vertical screw conveyor.

- 2. Use Soft Start** – A typical TEFC motor generates at least 150-percent of motor voltage and torque at start up when started with full voltage and current. A soft start provides a ramp up of voltage and current, greatly reducing the "hammering effect".

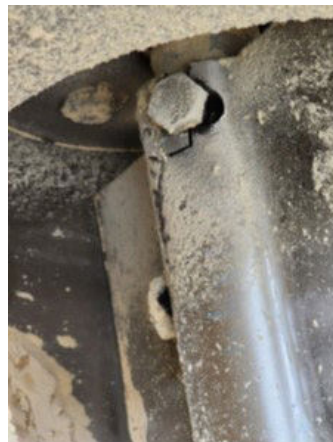
Use of Improper Coupling Bolts Contributed to Screw Failure

- 3. Use Proper Coupling Bolts** – The coupling bolts in the photos you sent clearly show that the wrong coupling bolts were used for the application. Proper coupling bolts are very important for long-term operation of screw conveyors. The shank length of a coupling bolt must be equal to the pipe diameter. Bolt threads are not allowed in the connection area. Threads in the connection area create clearance and reduce the shear strength of coupling bolts.

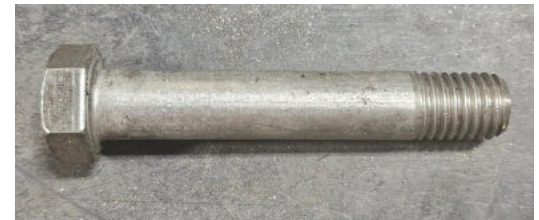
Repeated Stops and Starts Along with Improper Coupling Bolts Caused Screw Failure

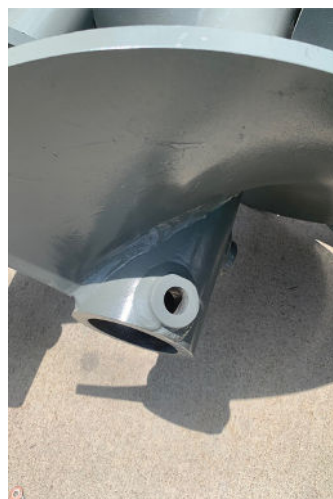
Coupling Bolt Shank Length is Always Equal to Pipe Outside Diameter

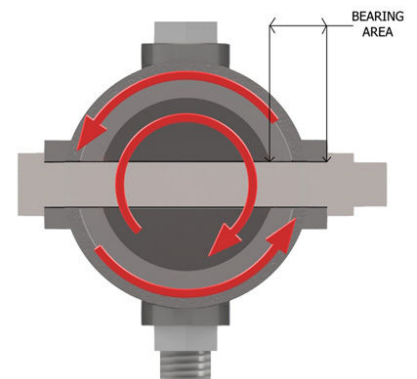
Typical Screw with KWS Bolt Pads

Bolt Pads Increase Bearing Area and Torque Rating of Connection

- 5. Add Bolt Pads to Screw** – Bolt pads add more bearing area to the CEMA 2-bolt or 3-bolt connection and greatly increase the torque rating of the connection. Greater bearing area also reduces the possibility of coupling bolt wear as there is a greater shear surface area.
