Internal Collar Failure

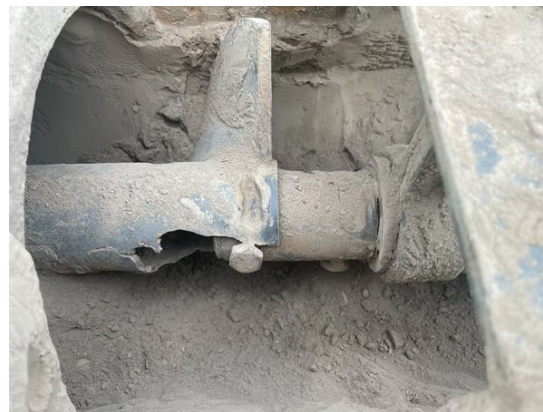
Thanks for contacting KWS and for sending the photo of the failed screw section. The screw failed because of improper welding of the internal collar to the center pipe of the screw. The internal collar broke loose from the center pipe of the screw causing the pipe to fail in torsion. The center pipe of the screw and internal collars must handle torque from the drive unit as a welded assembly. If the welds between the center pipe and internal collar fail, the complete screw section will fail causing an interruption to production.

Improper Plug Welds Between Center Pipe of Screw and Internal Collar are Cause of Failure

KWS understands the importance of creating a permanent connection between the center pipe of the screw and internal collars by providing four plug welds per bushing, with two plug welds located on each side 180-degrees apart. Plug welds provided on KWS screws are permanent, will not break loose, and are guaranteed for the life of the screw.
